## ADDENDUM

**Ireland Farm**  
**CT-26**  
**2133, 2165, 2169 Wilson Road**  
**Huntingtown, Maryland**  
**Amy Bolasky Skinner**  
**The Ottery Group, Inc.**  
**August 7<sup>th</sup>, 2009**

### **Section 7. DESCRIPTION**

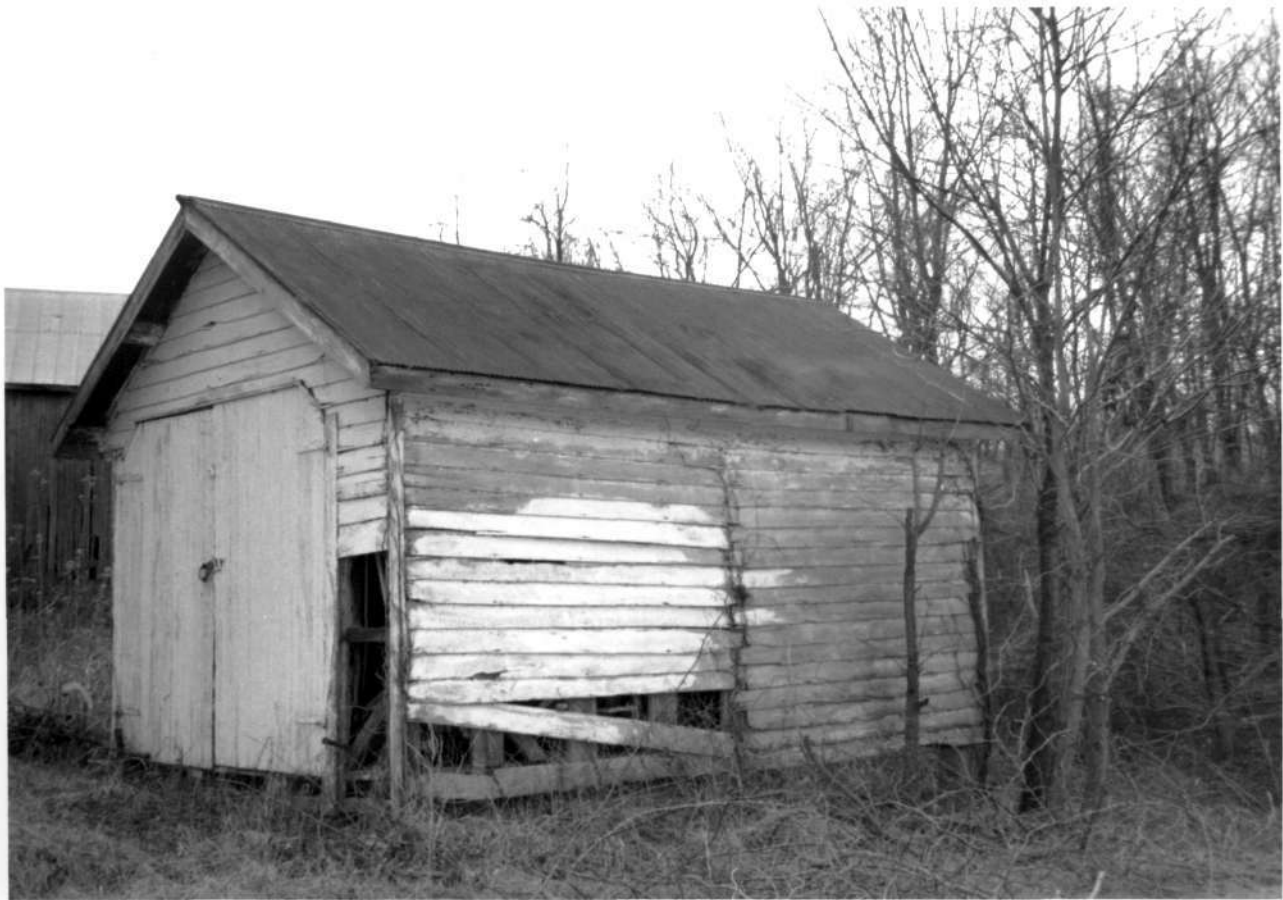
32 of 60

Shed 4 East Facade

Shed Four is located to the south off of Patience Place prior to the access road and the main farmhouse parcel. The shed does not meet Patience Place at a right angle but rather at a thirty degree angle with the principal façade facing northeast. The shed is at the roads end surrounded by a rolling agricultural field and undeveloped forest north of Barn Three. The outbuilding is a one-story, one-by-one bay building with a rectangular plan. The steeply pitched, metal standing seam shed-roof has a thick cornice and overhanging eaves. The building is of wood-frame construction with a foundation that is not visible. The exterior is clad in narrow, wood weatherboard. The batten double door is asymmetrical on the northeast façade in the southeast bay. The corners of the door are cut on an angle. The exact use of this shed is unknown. Alterations have been made to the shed over the course of its use. The exterior sheathing on the west elevation meets in the middle of the shed as if the shed was expanded. The exterior is no longer weatherproof as horizontal boards are missing on the northwest façade adjacent to the door as well as on the west elevation.

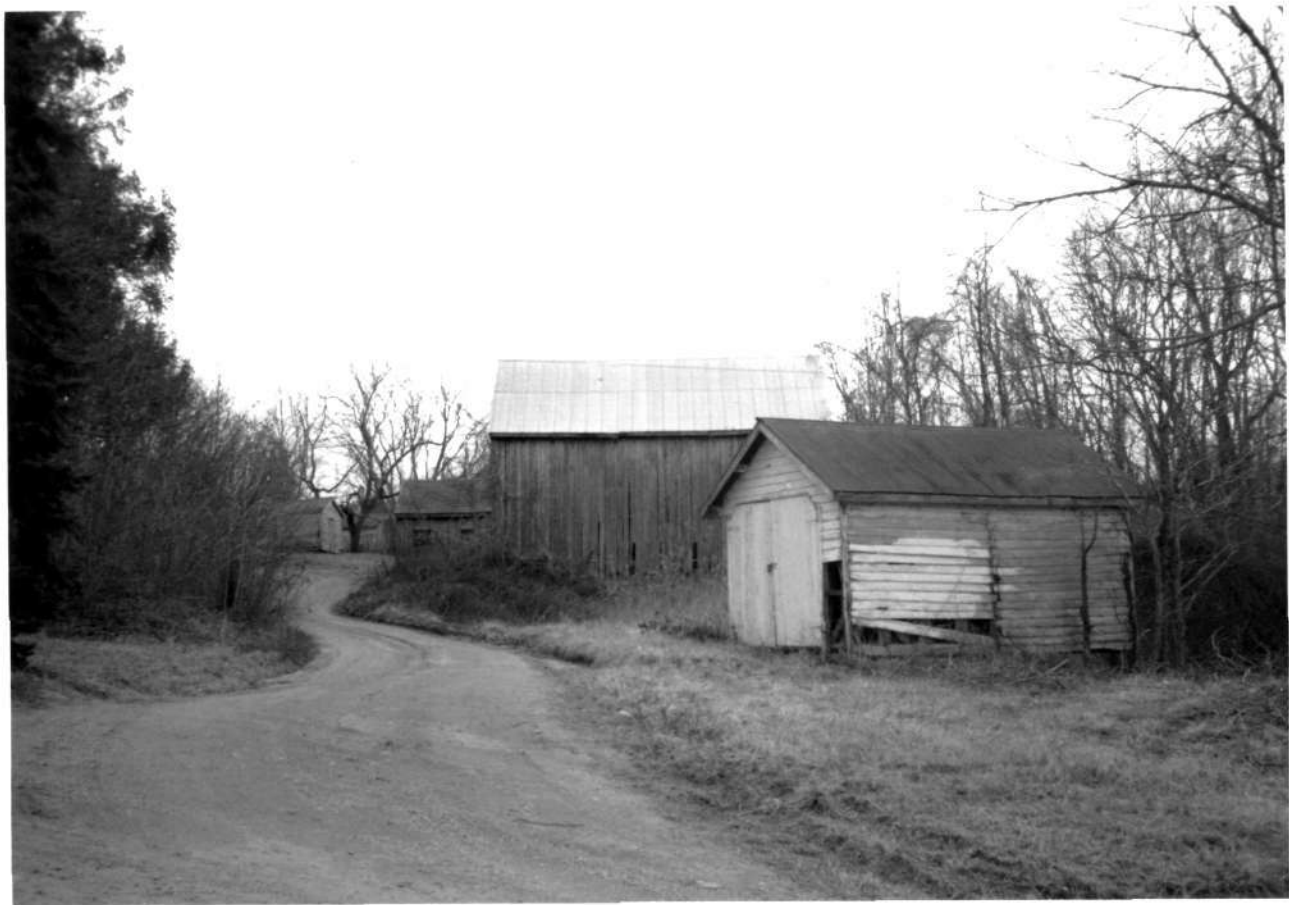
33 of 60

Shed 4 North Elevation

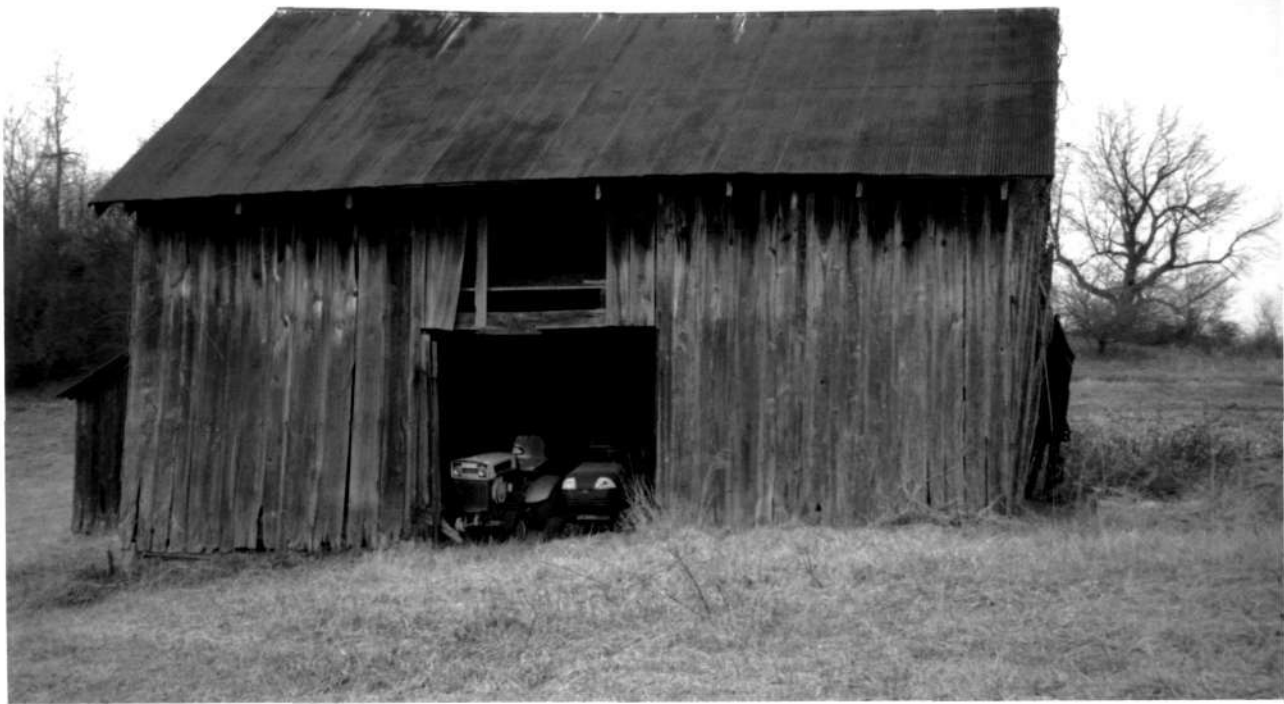
35 of 60

Barn Four has a steeply pitched, side-gable roof clad with corrugated metal. The roof has overhanging eaves and exposed rafter tails. The barn has a concrete block pier foundation visible only on the west elevation and south façade. The barn is of wood-frame construction with an interior stall. The exterior is clad in vertical, rough-hewn wooden planks. Barn Four has a large opening on the south façade that is wide and tall enough for farm equipment to be stored in the building. The barn's garret is visible as vertical planks have been removed above the opening. There were double, wood plank doors on the east elevation but the north wall has partially collapsed.<sup>7</sup> Barn Four is a good example of non-tobacco barn types, namely equipment storage, used on farms in the twentieth century.

Barn 4 South Facade

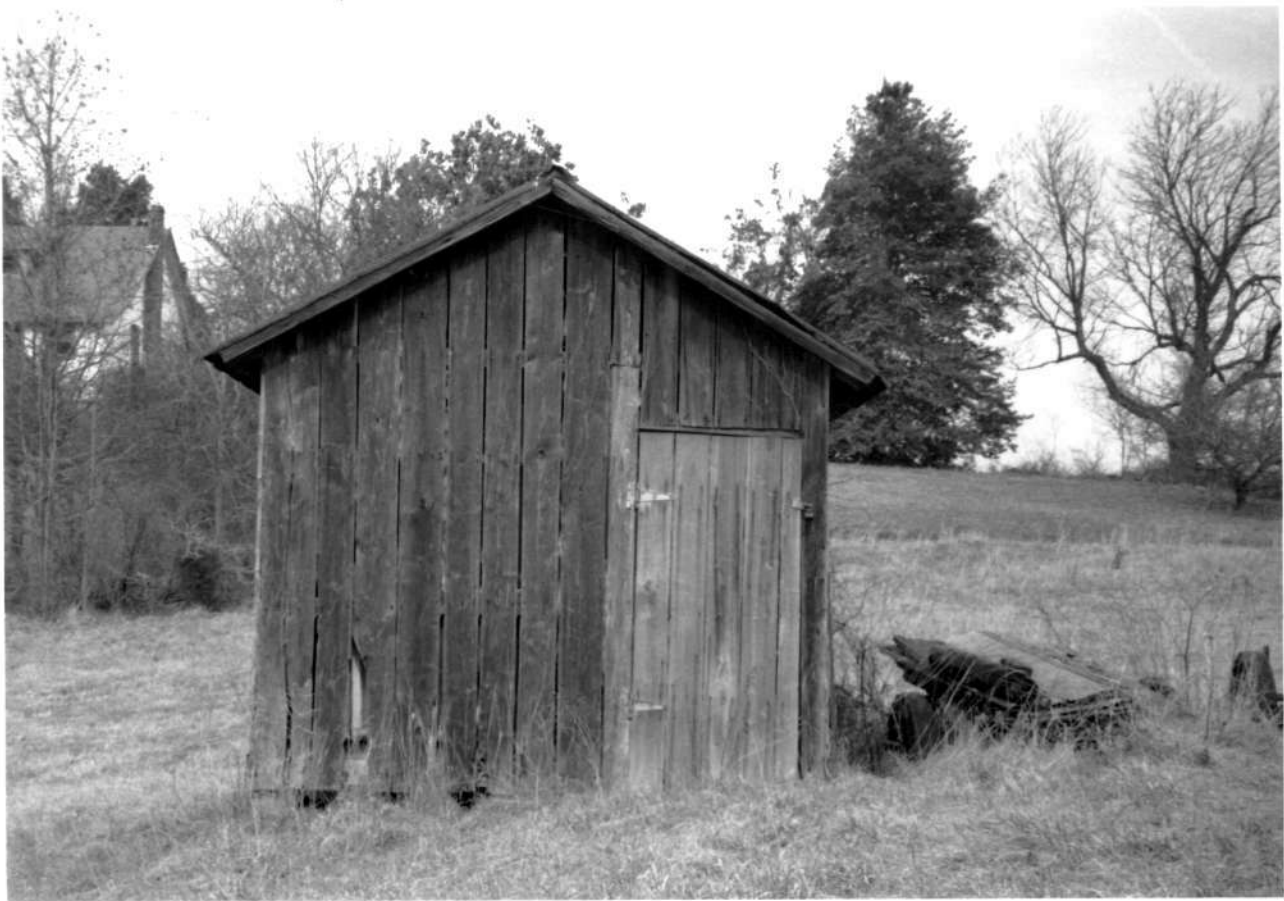
37 of 60

Shed Five is located just north of Patience Place past Wilson Road clustered with Barn Four. Shed Five is surrounded by an agricultural field and is the only shed on the northern parcel of the Ireland Farm. The outbuilding is a one-story, one-by-one bay building with a rectangular plan. The front-gable roof is of steep pitch clad with corrugated metal sheathing, exposed rafter tails and overhanging eaves. The building is of wood-frame construction with a concrete block pier foundation on the north and west elevations. The exterior is clad in various types of vertical plank boards, both rough-hewn and machine-cut. Varying exterior materials is common on farms as exterior siding often needs partial or full replacement. The south façade is clad with machine-cut boards of similar width that are not flush. The building's trussing and support system is exposed on the east elevation; the interior vertical wood siding is visible through the trussing. There is a batten, wood plank entry door in the east bay of the south façade. Although likely used for storage the exact use of this shed is unknown.

Shed 5 South Facade

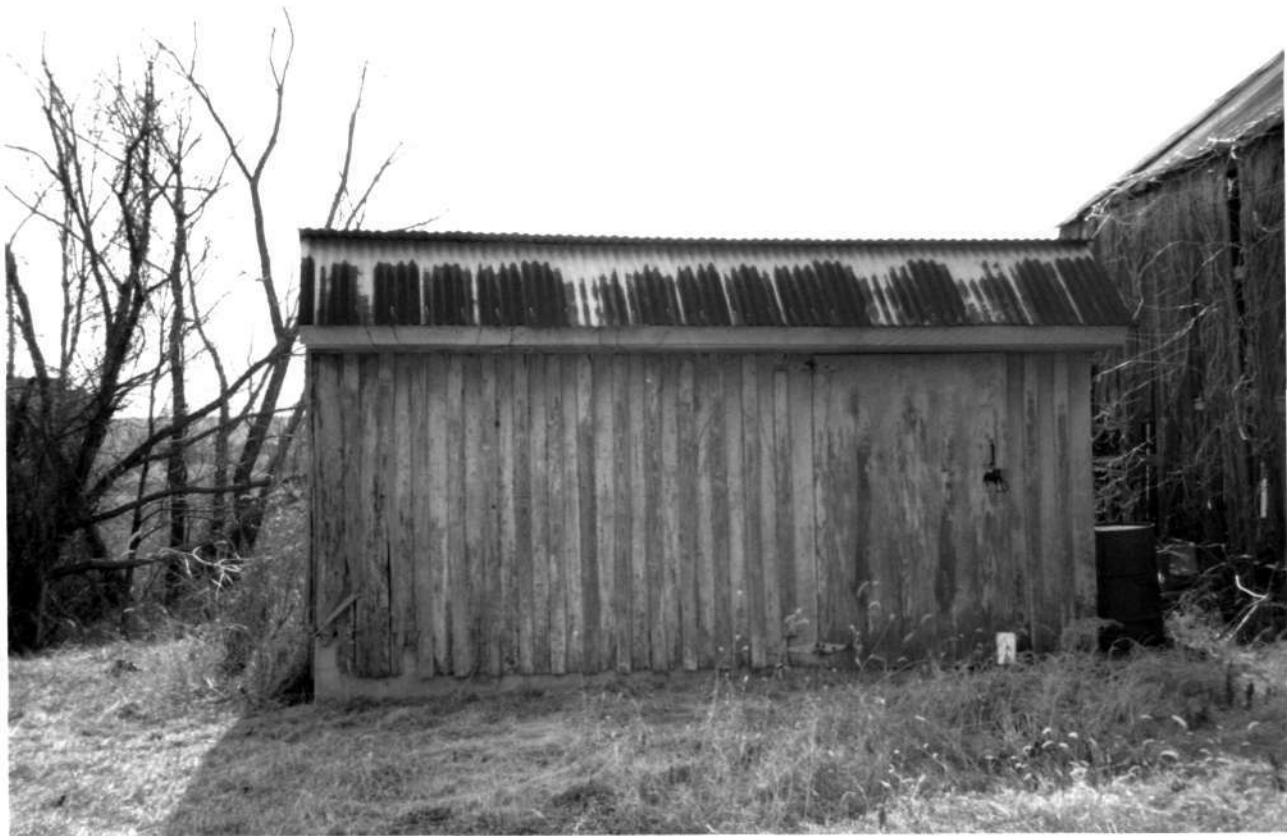
51 of 60

Shed Six is located east of, and adjacent to, Barn Five and southeast of the fork in the road along Patience Place. The shed is surrounded by rolling agricultural fields. The outbuilding is a one-story, two-by-one bay building with a rectangular plan. The shallowly pitched metal standing seam shed-roof has overhanging eaves. The building is of wood-frame construction with a concrete block foundation. The exterior is clad in board and batten wood planks. There is a flush door on the north façade that is tightly secured. There are two, two-pane, fixed wood windows on the east elevation. On the south elevation is a pair of centrally located, two-pane, fixed wood windows that are missing their glazing and are in poor condition. The south elevation is weatherproofed and possibly stabilized below the window sills by a secondary sheathing of corrugated metal sheets. The cornice on the south elevation has fallen off the roofline. The exact use of this shed is unknown although due to its proximity to the tobacco barn and remote location on the property it was likely a workshop or stripping room.

Shed 6 North Facade

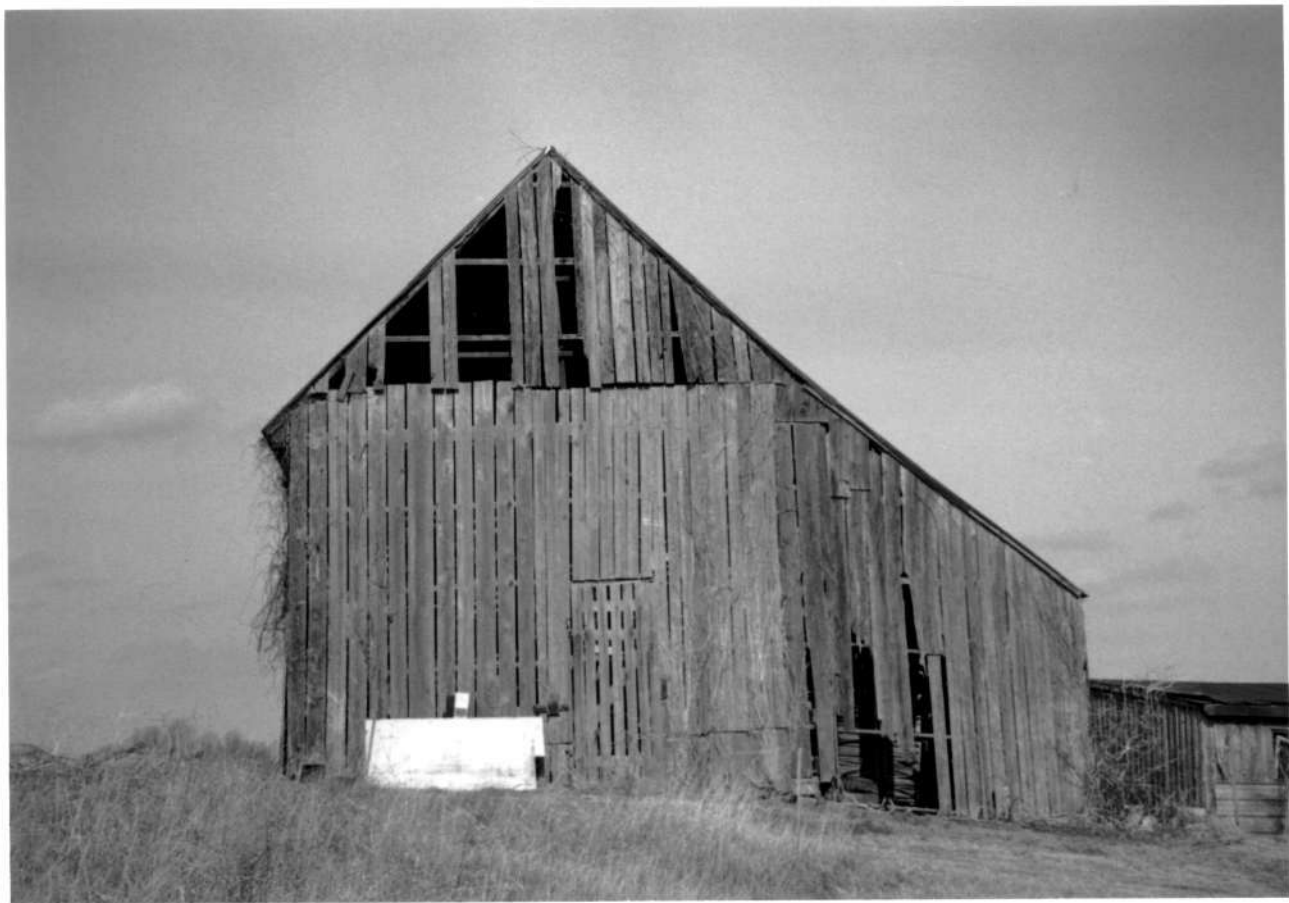
52 of 60

Shed 6 South elevation

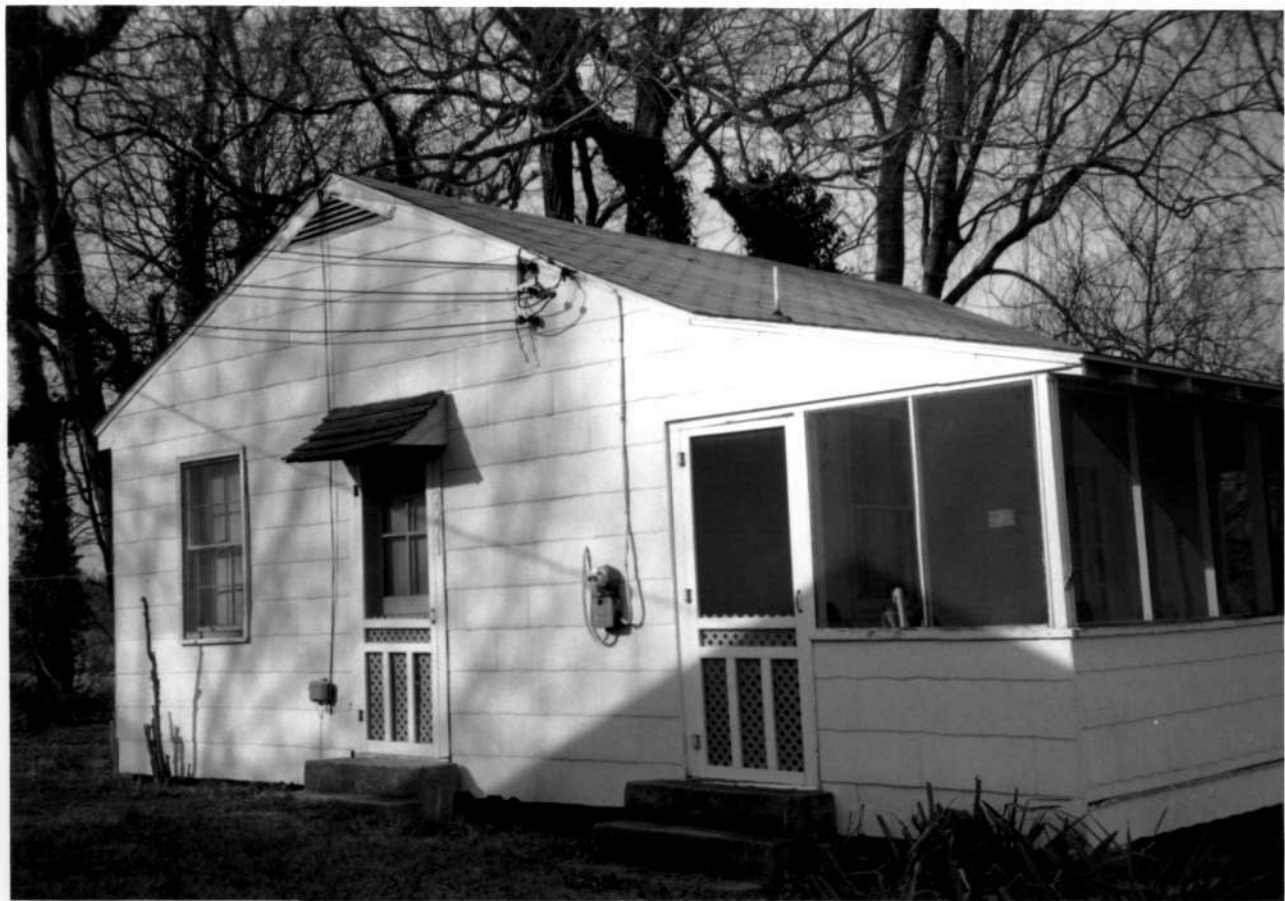
56 of 60

Inland's Beach Cottage 6 East Facade

All six cabins are of similar type and massing; one-story, three-by-two bays with side-gable roofs and a shed-roof porch on the main façade. The side-gable roofs are of shallow pitch and are clad with asphalt shingles. The cabins are wood-frame with a raised, concrete block foundation. The exteriors are clad with various materials depending on when they were updated. Cabin One is the only dwelling with the original exterior weatherboard. Cabins Two, Three, and Four are clad in a secondary sheathing of vinyl siding while Cabins Five and Six are clad in a secondary sheathing of asbestos siding. Cabins One, Two, Five, and Six, have retained the original six-over-six, double-hung sash wood windows. Cabins Three and Four have replacement six-over-six, double-hung sash vinyl windows. Window surrounds are either vinyl or wood depending on the window material. Entry access is off of the side south elevations or through a screen door on the south elevation's porch. Doors are glazed, wood panel with wood casings. The porch on the east façade is full-length, one-story and three bays. The porch is partially enclosed by a low, wall with screens above. The wall is clad in the same exterior materials as its respective cabin. Only Cabin Five has a fully enclosed porch (no screens). The cabins are in varying but overall good condition as the rental tenants often update and maintain the buildings at the start of each summer season.

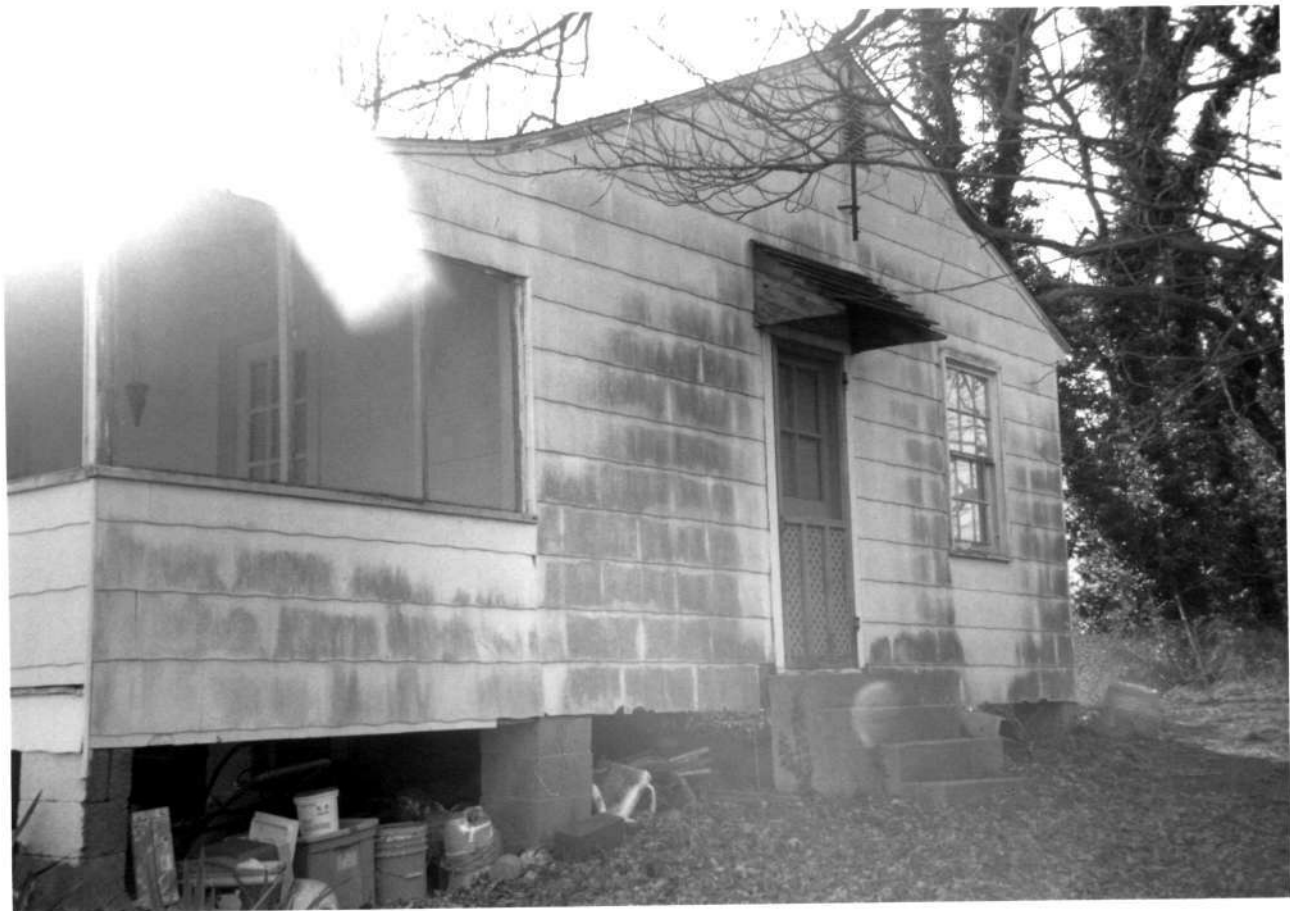
57 of 60

Ireland's Beach Cottage 6 South Elevation

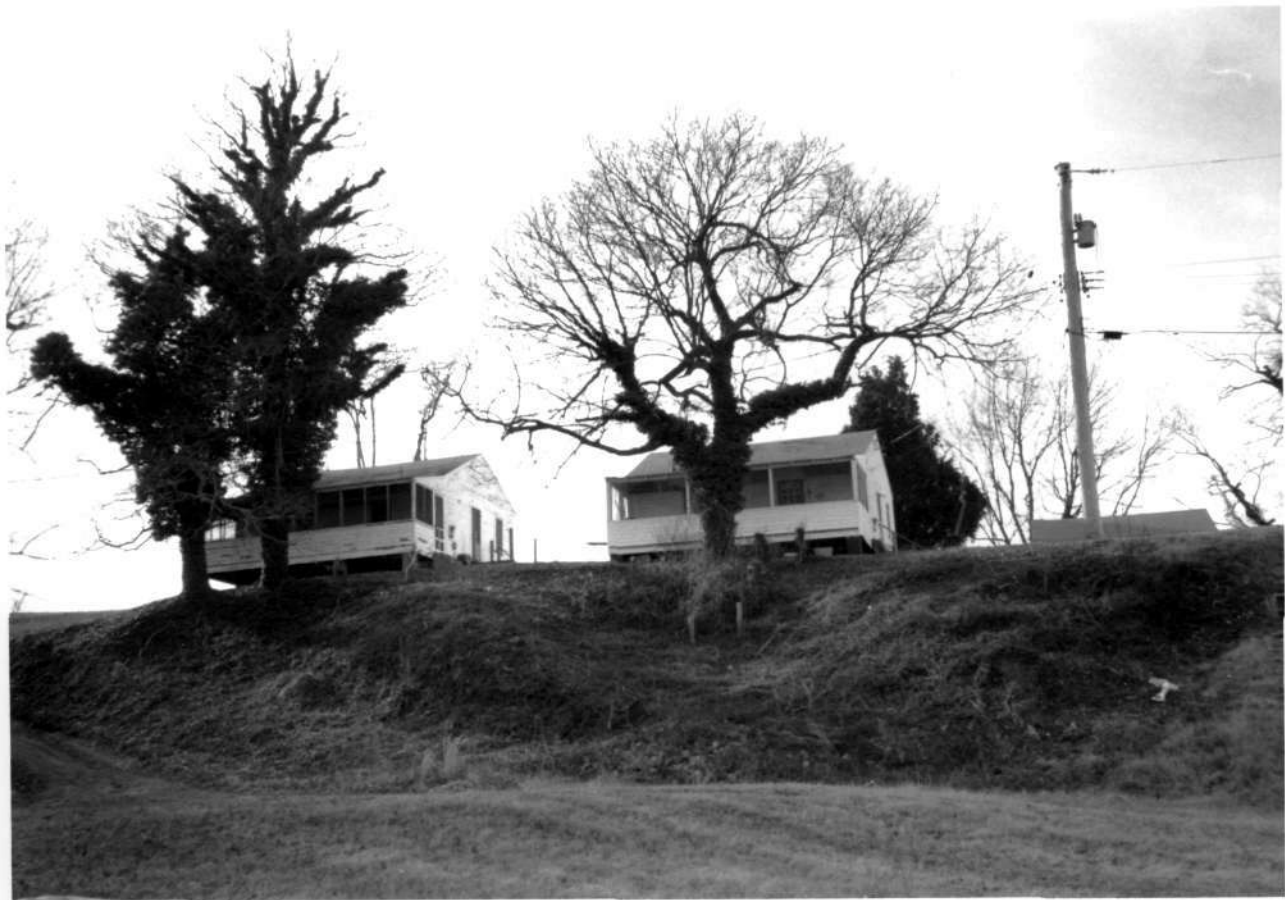
58 of 60

Ireland's Beach Cottage 6 North Elevation
